Tool condition monitoring for precise evaluation of milling efficiency

Abstract

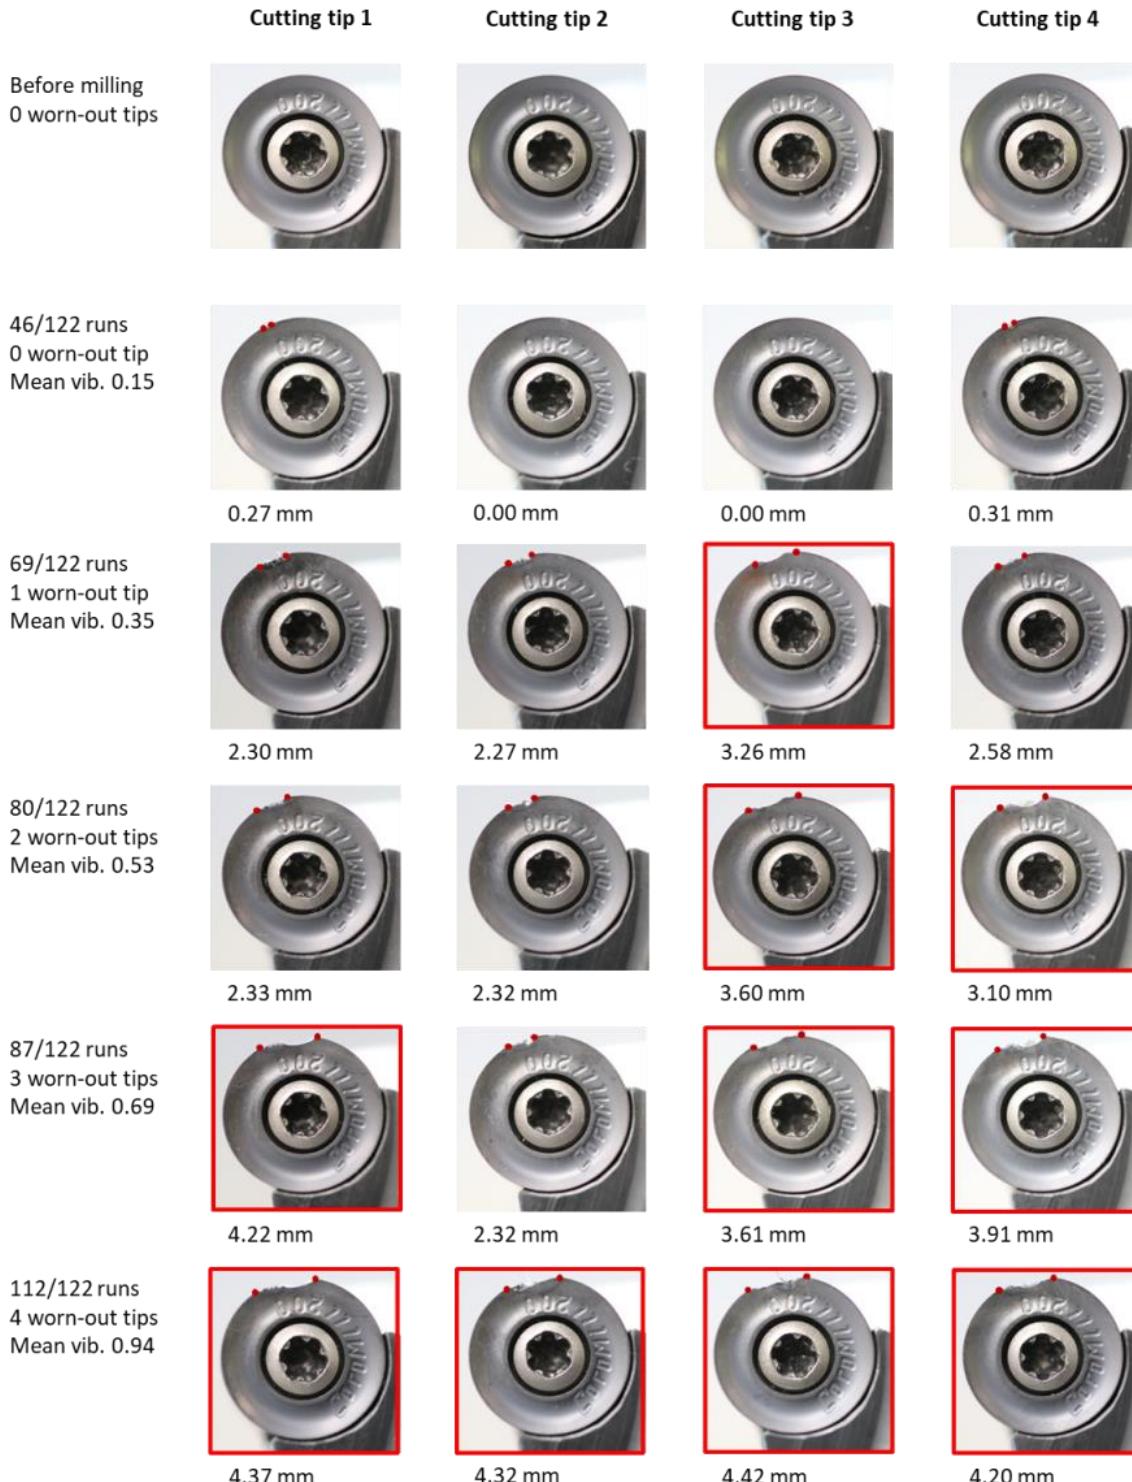
Figure 3: Example for evaluation of functional state of cutting tips within one milling cycle. The cutting tip was regarded worn-out and insufficient as soon as the break-off edge was longer than 3.1 mm and exceeded the maximum point of the cutting sector (marked by red border). The mean vibration value was calculated for each stage with the respective number of insufficient and worn-out cutting tips.

As a consequence, the cutting tip was regarded as insufficient because it did not contribute to the complete removal of the aimed cutting depth of 0.8 mm (Figure 3).
